New Firmware for RAC & ESTIA Wireless Adapters

This Bulletin describes the latest firmware which has been developed to support fast roaming mode for RAS and ESTIA wireless adapters by integrating the new WLAN library patch

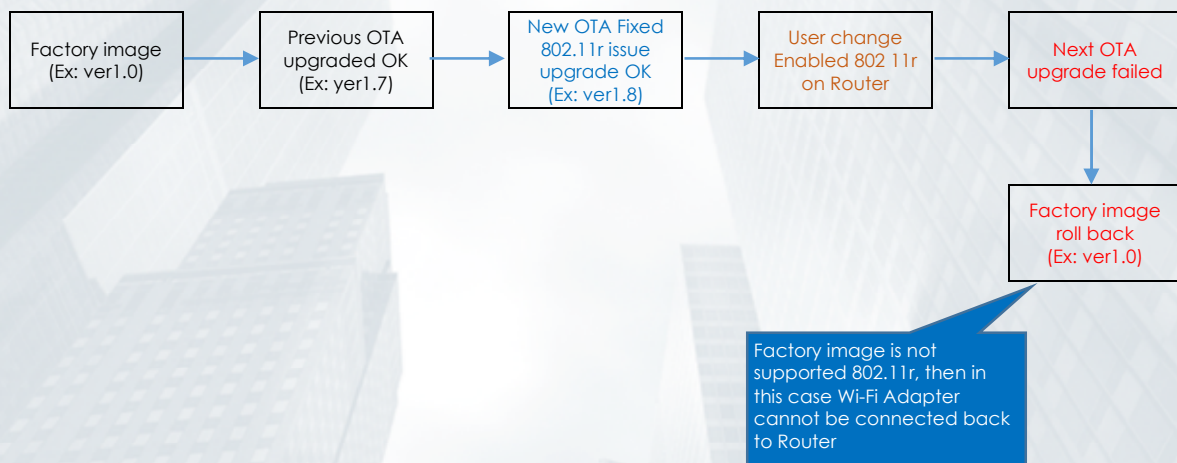
SCENARIO: Problem if OTA update failed

- Wi-Fi Adapter firmware will revert back to Factory default firmware image when OTA update is failed by end user (from internet issue or power loss during OTA upgrade)
- Factory default firmware image is not supported for 802.11r fast roaming
- Below scenario will cause Wi-Fi Adapter cannot connected back to the Wi-Fi Router after OTA upgrade failed
